Adaptive Management of Elevated Nesting Habitats

Ring Island Elevated Nesting Habitat

Great Flats Elevated Nesting Habitat

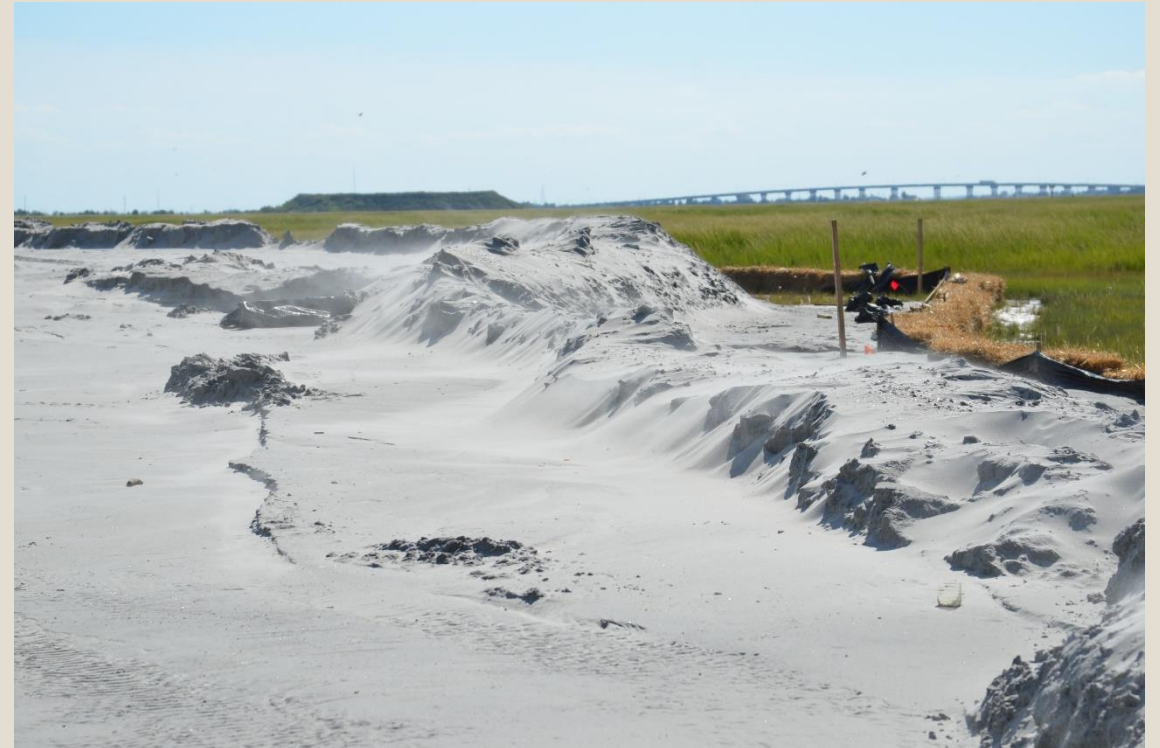
Construction considerations	NAVD88
Set target above MHHW	2.1 ft
Habitat above spring tide	3.6 ft
Habitat above storm flood elevations	5.5 ft
Allow dewatering, compaction, elevation loss	6.0 ft

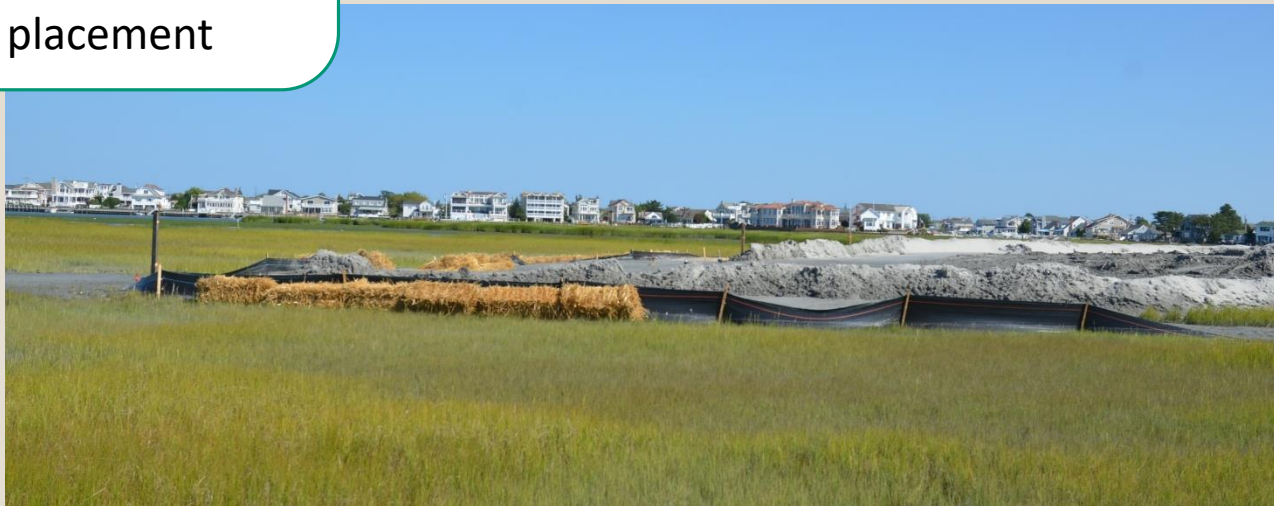
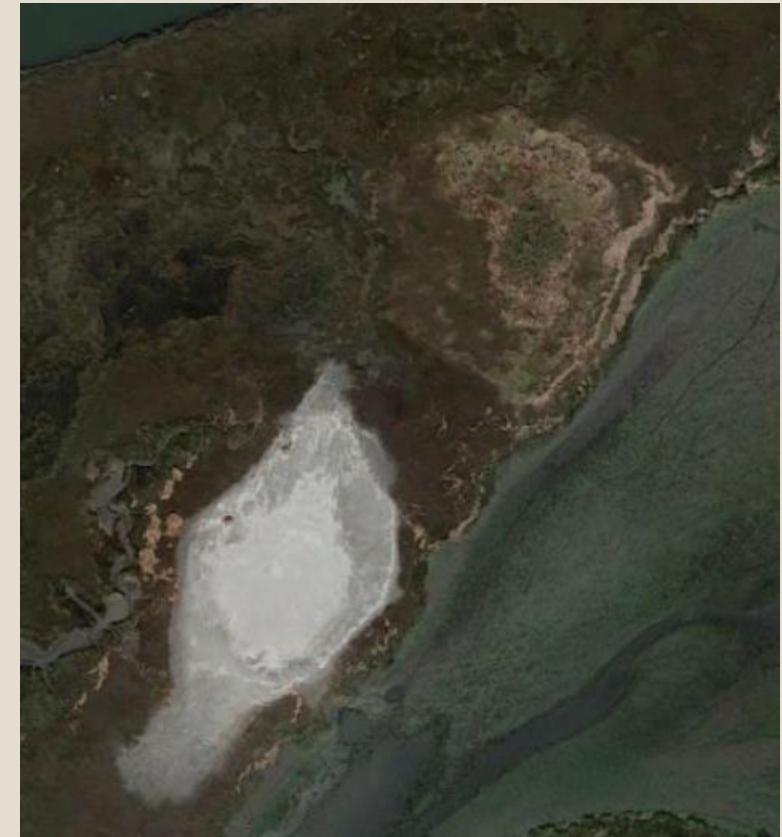
AUGUST: Created Elevated Nesting Habitat for Black Skimmer colony

- 96% sand from channel shoal
- Open, sparsely vegetated habitat above spring high tide
- Protected from predation and disturbance

- 6,000 CY dredged material
- ~ 1 acre
- 5.5' ecological target
- 6.0' construction target
- Near legacy placement

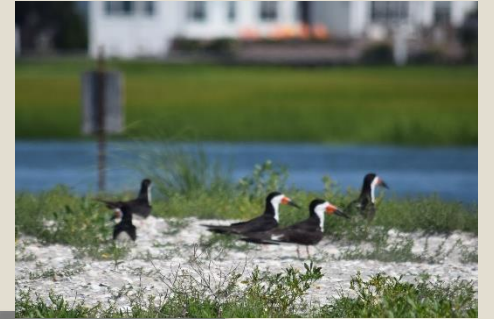
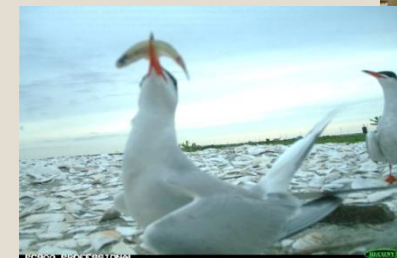
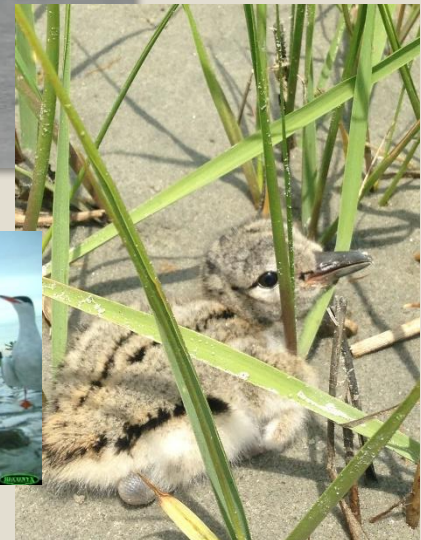
2015 - 2017: Annual monitoring - AVIAN

- Increase in number of species and nests each year
- American Oystercatchers and Least Terns first to establish
- Black Skimmer and Common Tern colonies by 2017

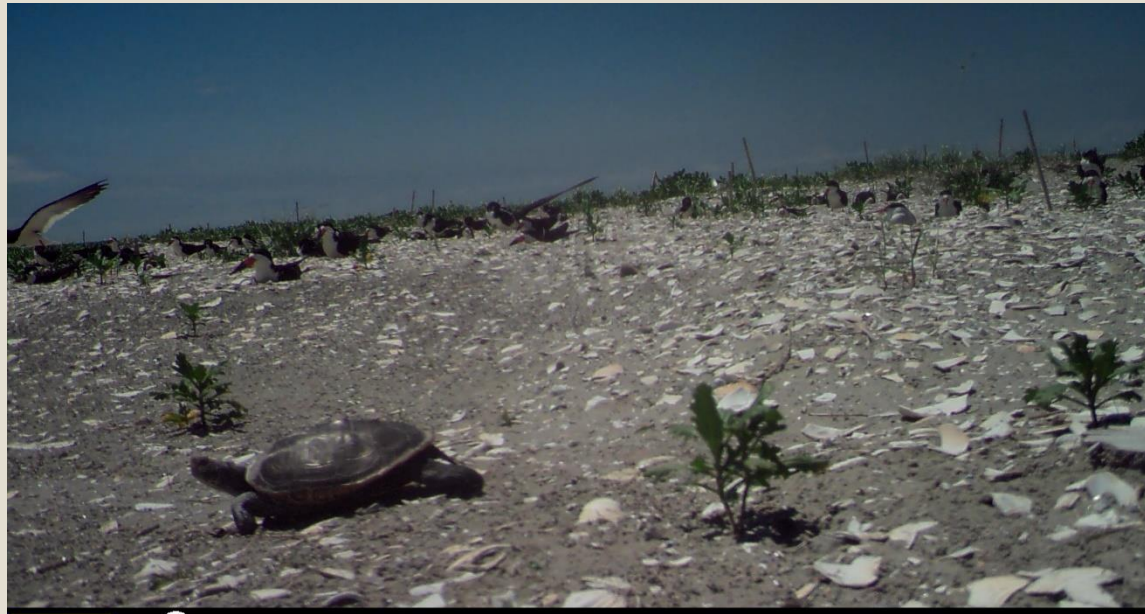
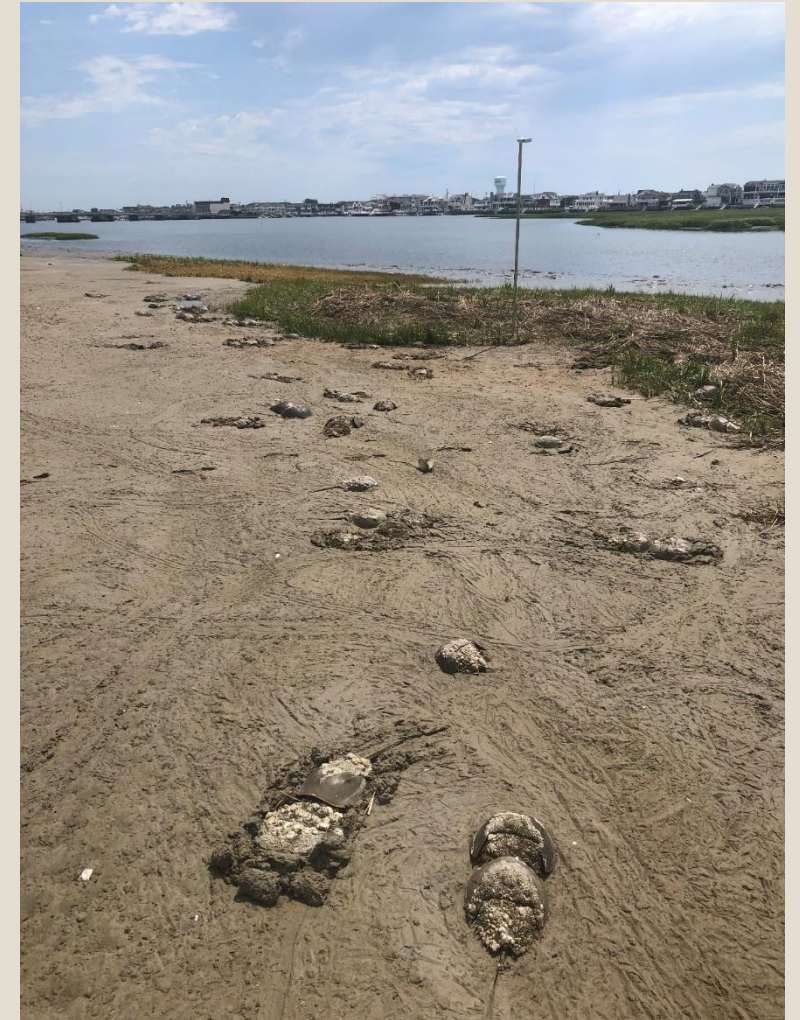
2015 - 2017: Annual monitoring - AVIAN

- Marsh-nesting species nested in vegetation around perimeter of habitat – Willet, Clapper Rail, Seaside Sparrow
- Shorebirds and other species roost and forage on site
- Horseshoe crab spawning and diamondback terrapin nesting

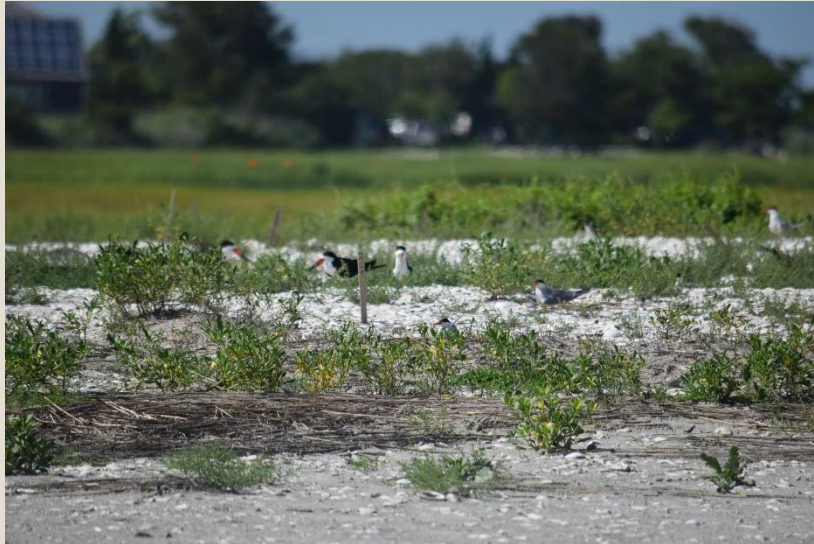
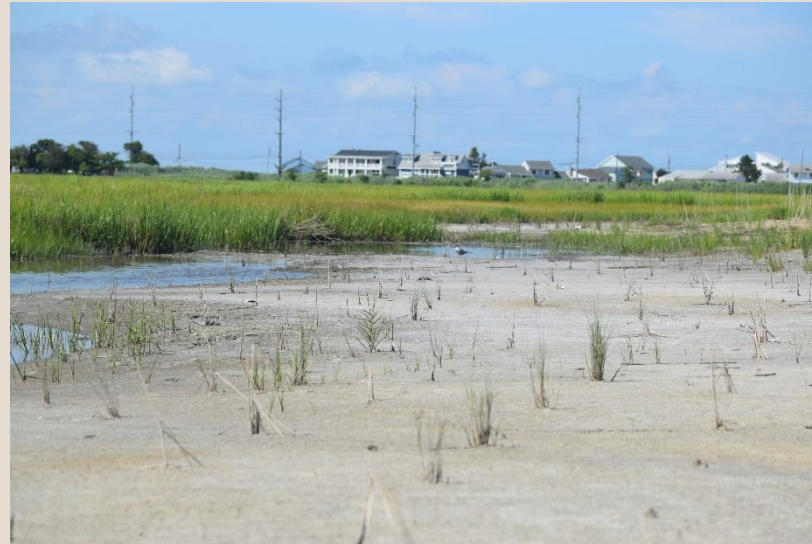
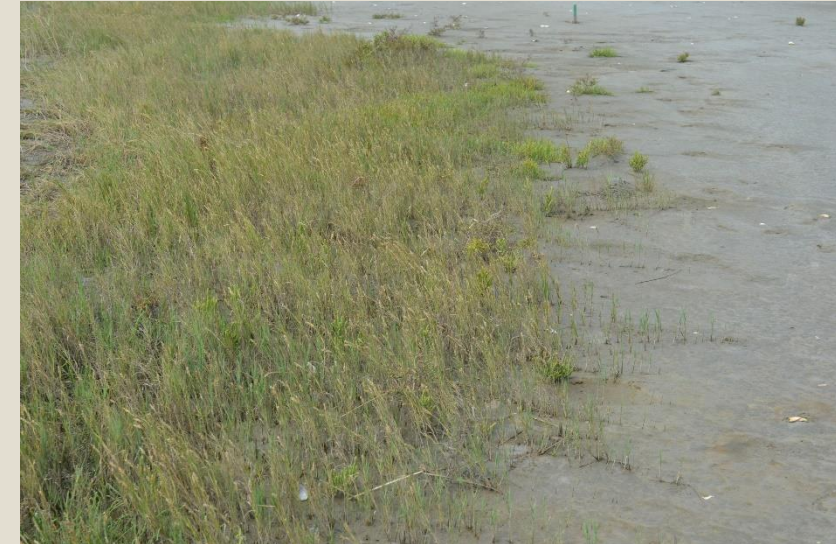
2015 - 2017: Annual monitoring - VEGETATION

- No formal surveys on ENH but observable increase in vegetation on nesting platform in 2017
- *Distichlis spicata* and *Spartina patens* planting and natural recruitment around perimeter of habitat

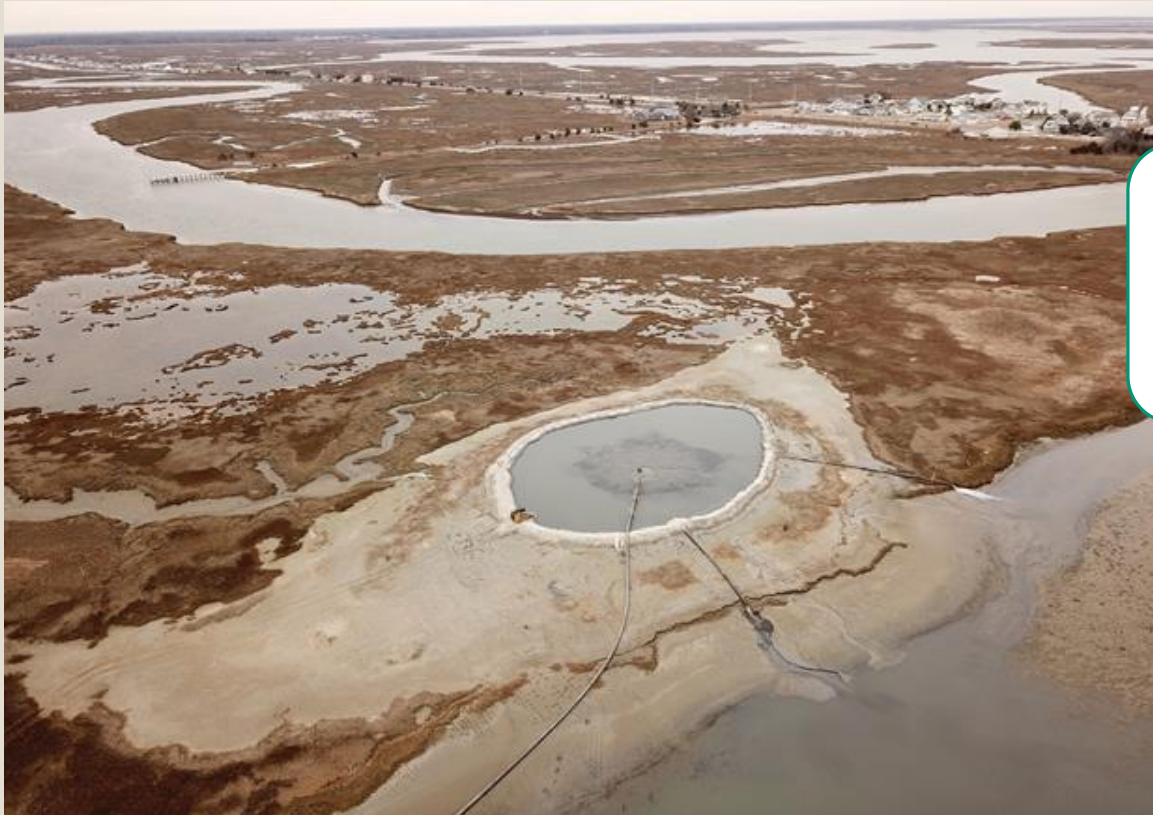
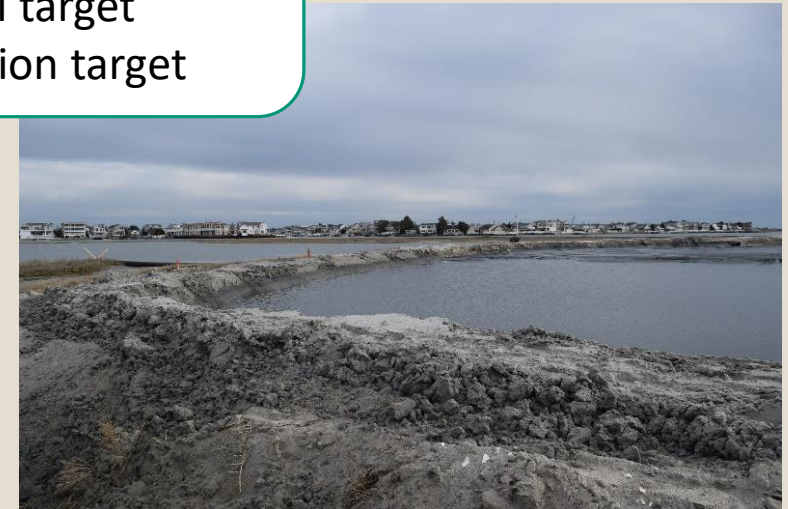
FEB-MARCH: Repetitive placement: resupplied sediment from the same shoal

- Build larger, higher platform for nesting
- Disrupt establishment of vegetation on the platform
- Maintain vegetation around perimeter

- 1,200 CY dredged material
- Berm existing material
- 5.5' ecological target
- 6.5' construction target

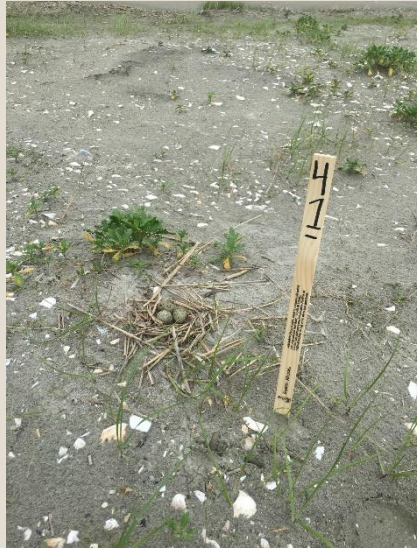
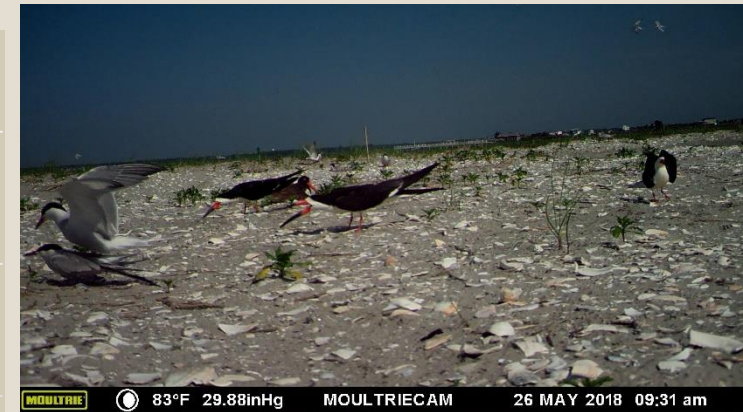
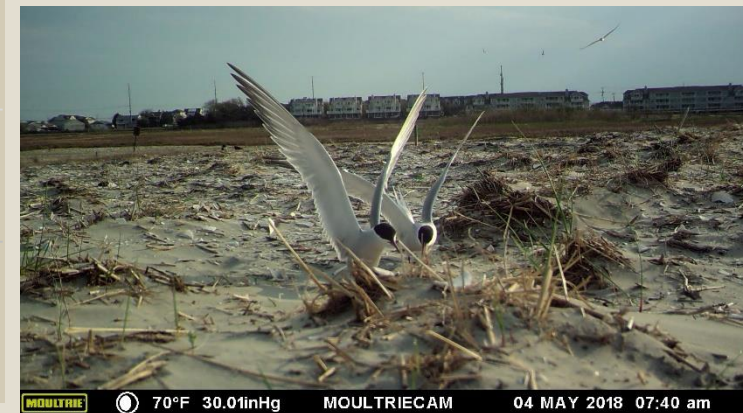
2018: Annual monitoring

- AVIAN: More birds used available habitat
- VEGETATION: Platform vegetation re-established; perimeter vegetation grew

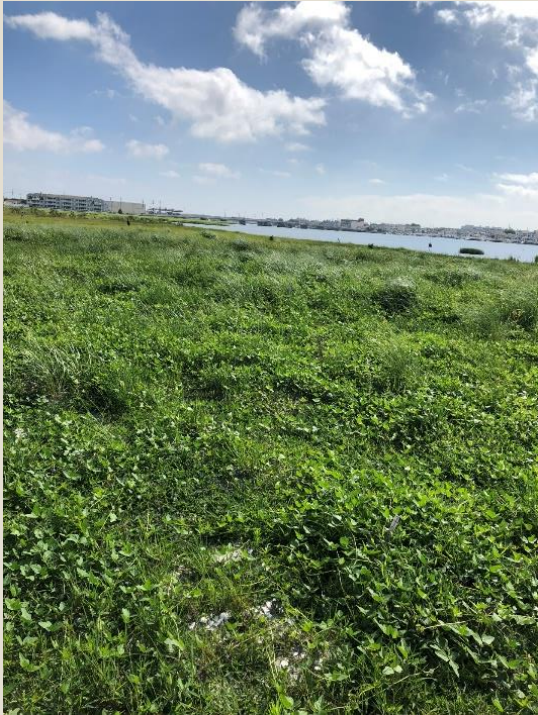
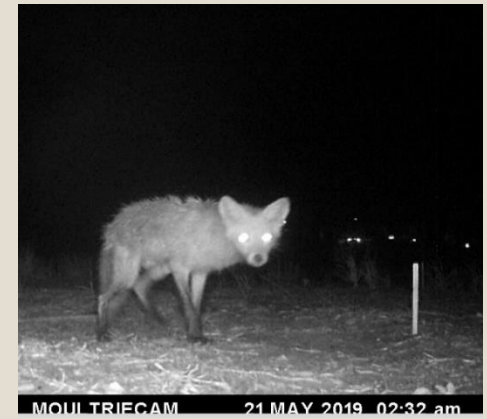
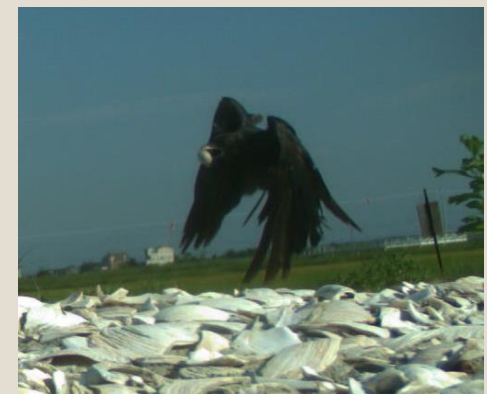
2019-2020: Annual monitoring - AVIAN

- More habitat management challenges as the ENH matured
- Number and success of nesting species declined

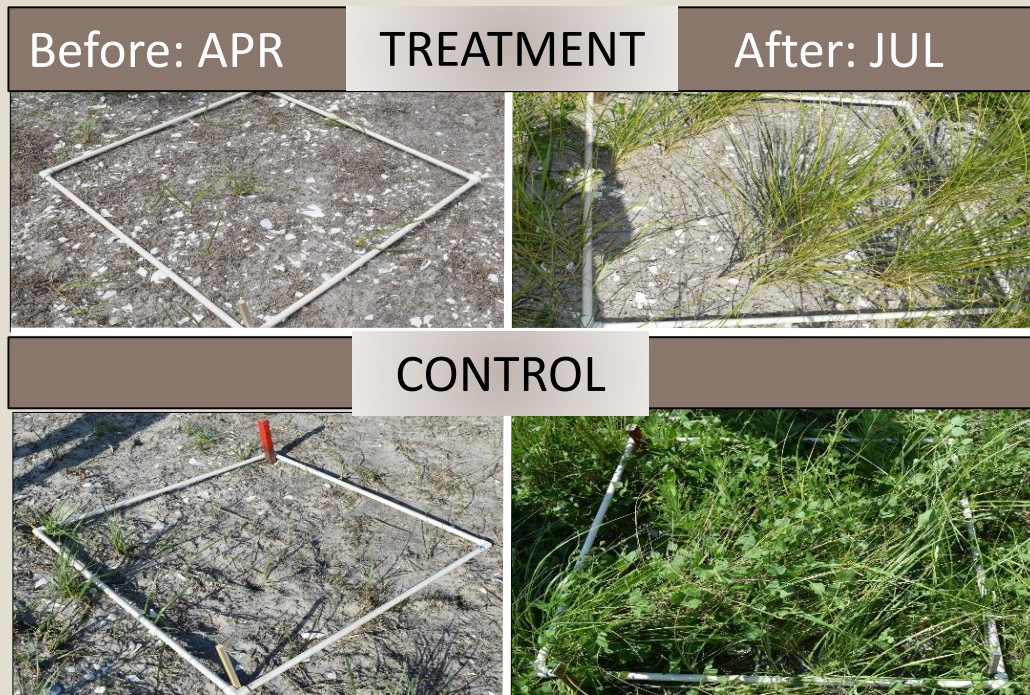
2019: 1 m² experimental plots

- Management: controlled fire, hand-pulling, concentrated salt treatment
- Minimal management in 2020

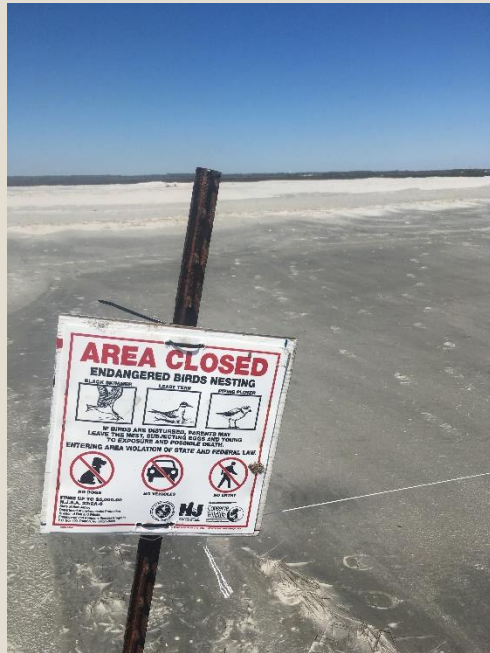
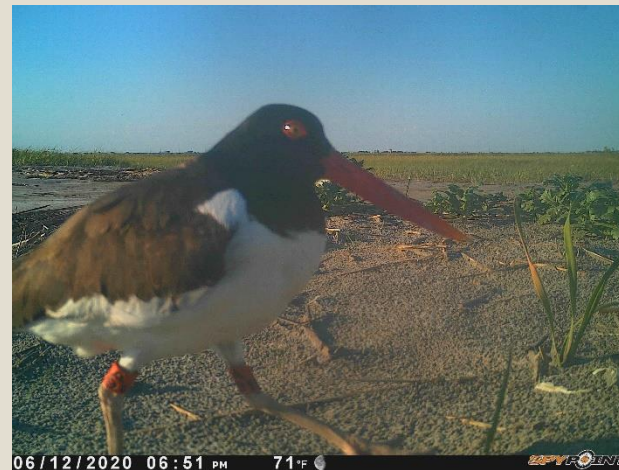
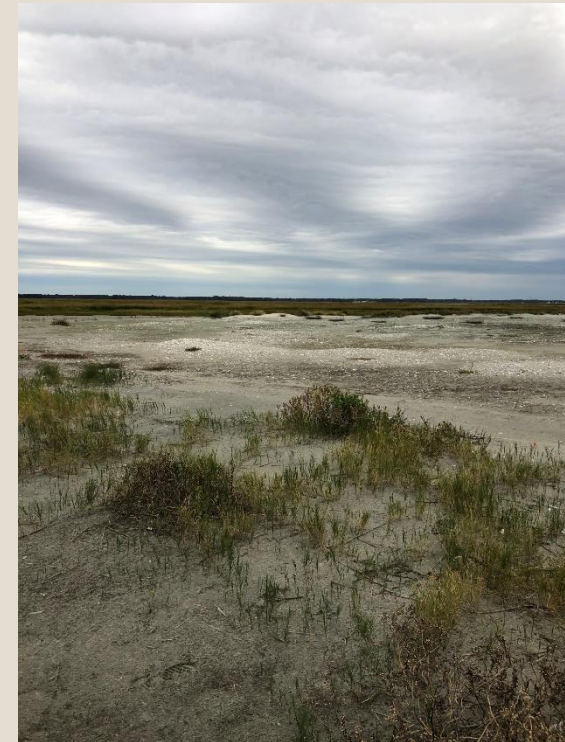
2019-2020: Annual monitoring - AVIAN

- Small number of species and pairs nesting: American Oystercatcher and Great Black-backed Gulls
- No colonial species (terns, skimmers) to date
- Predators (fox in 2019), vegetation, and elevation loss

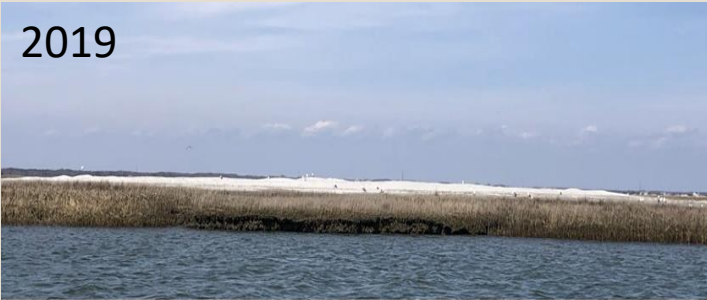
2019

2021: January repetitive placement to add elevation

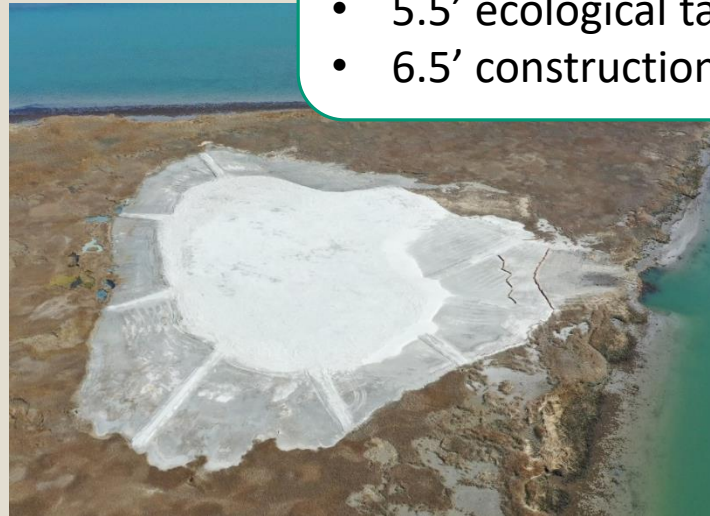
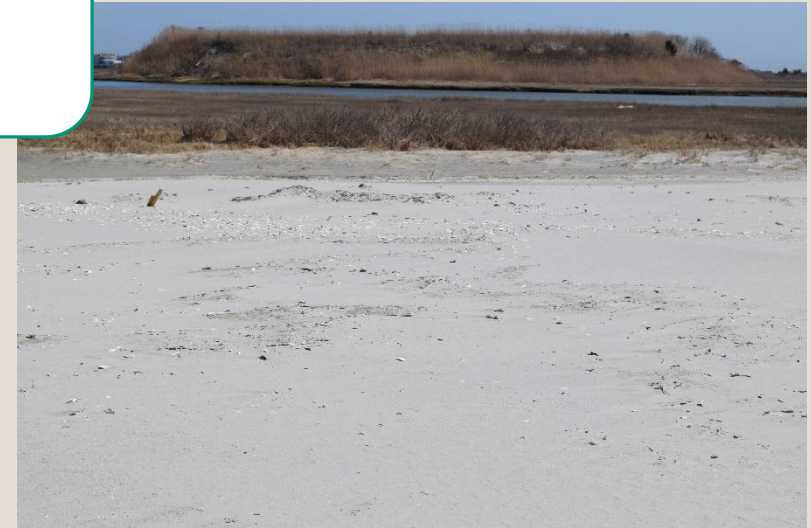
- Expand footprint, add and test design features
- Provide early successional habitat as Ring ENH matured
- Monitoring ongoing through 2021

- 3,900 CY dredged material
- Berm existing material
- 5.5' ecological target
- 6.5' construction target

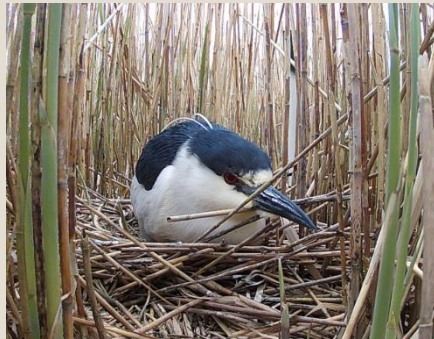
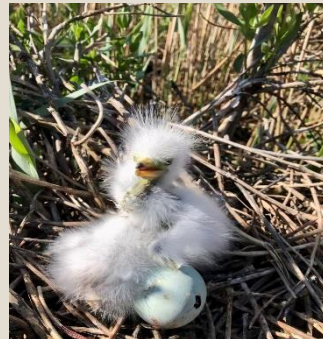
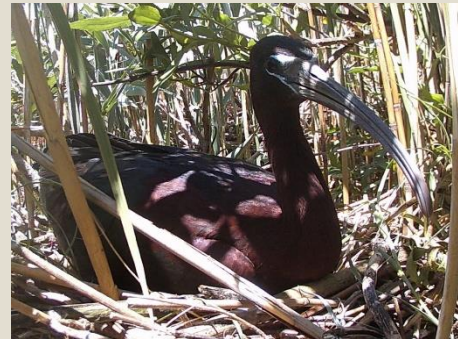
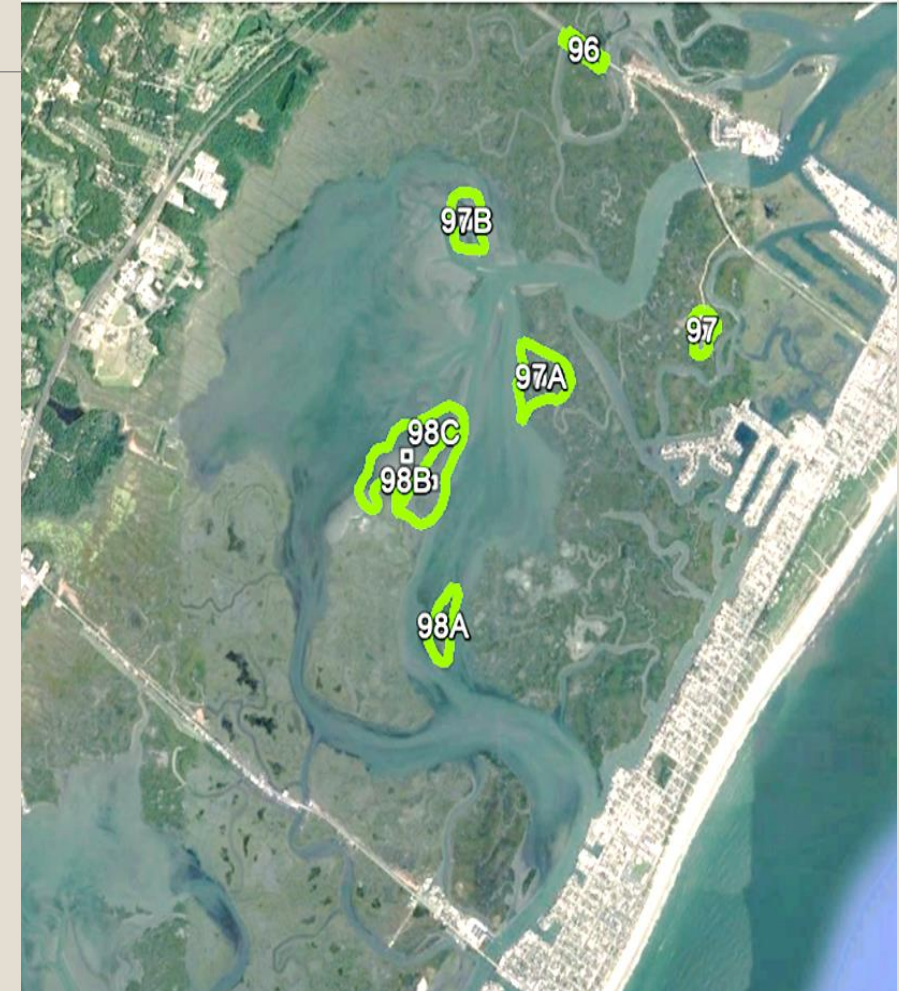
Gull and Sturgeon Islands

- Legacy placement sites created important wading bird nesting habitats (98A,B,C in SMIL)
- Nesting habitat includes Phragmites, woody shrub, and trees
- Gull and Sturgeon Island colonies support ~27% of colonial nesting wading birds in New Jersey (NJDFW, 2018)
- Habitat on both islands is degrading: flooding, habitat loss, density-dependent impacts, competition

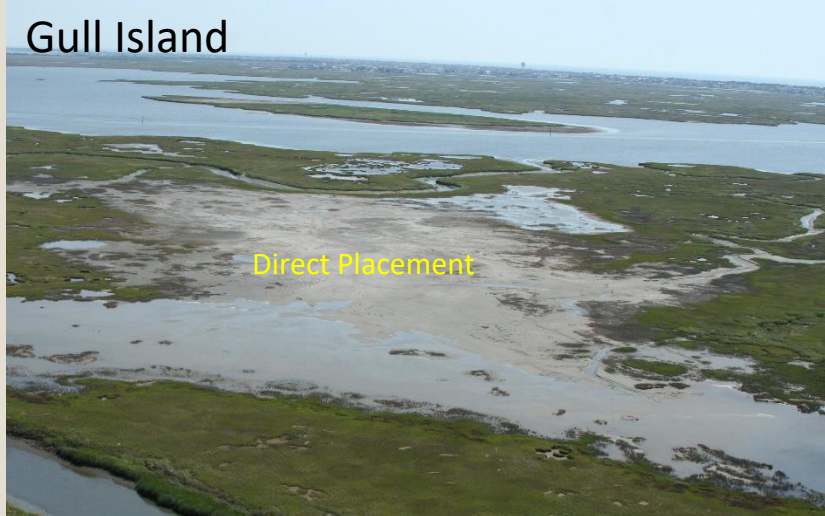
Gull Island

Direct Placement

- Sediment placement to create Elevated Nesting Habitat for wading birds
 - Target Elevation 3.5' NAVD88; shrub habitat elevation benchmark
 - Repetitive placement to reach target
 - Existing nesting habitat was not impacted
 - Will require habitat monitoring and management to accelerate habitat maturation for wading birds and other marsh-nesting species
 - Initial years may provide habitat for species that prefer early successional habitat

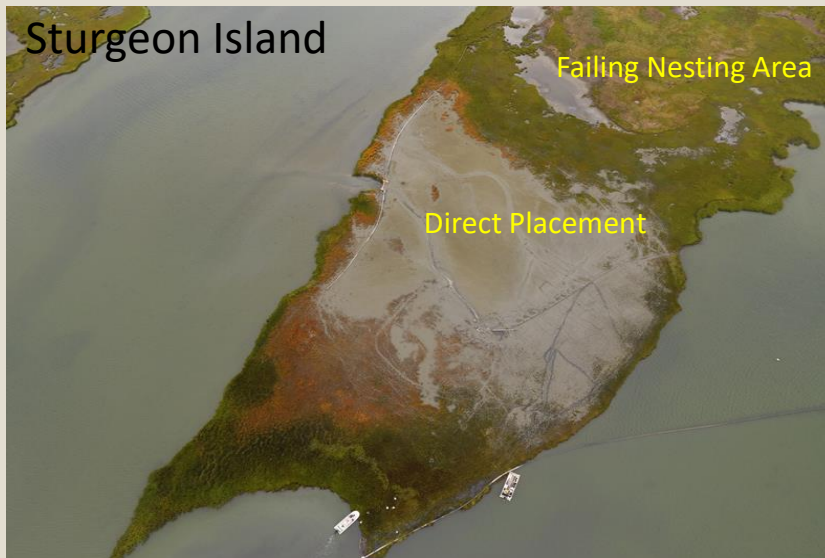
Sturgeon Island

Failing Nesting Area

Direct Placement
