The Placement and Fate of Subaqueous Berms for Marsh Edge Protection and Intertidal Flats Enhancement

2022 Annual SMIL Working Group Meeting
September 7, 2022

Seven Mile Island Innovation Laboratory

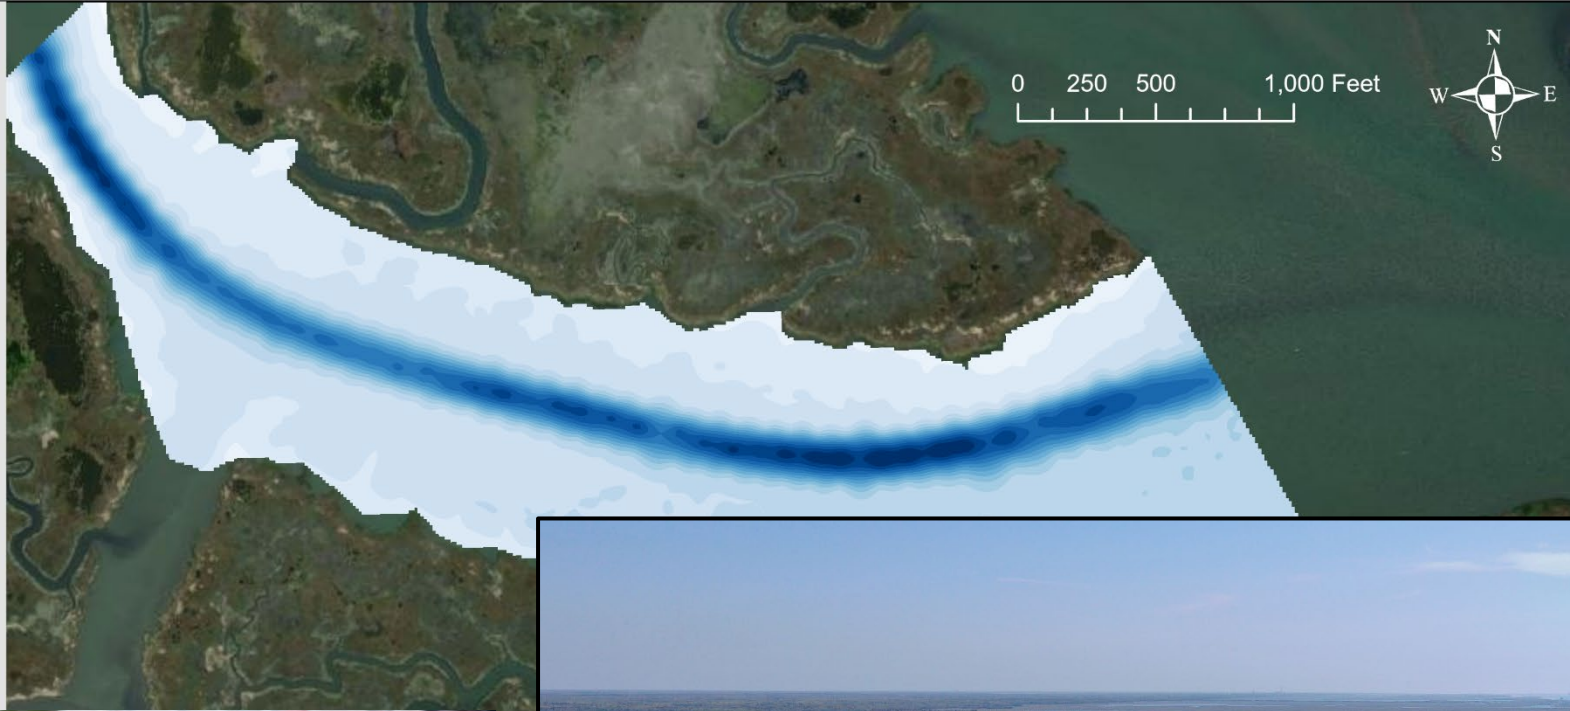
Bathymetry Southern Gull Island August 2020

Loss of critical
bird habitats in
the marshes and
tidal flats of Gull
Island

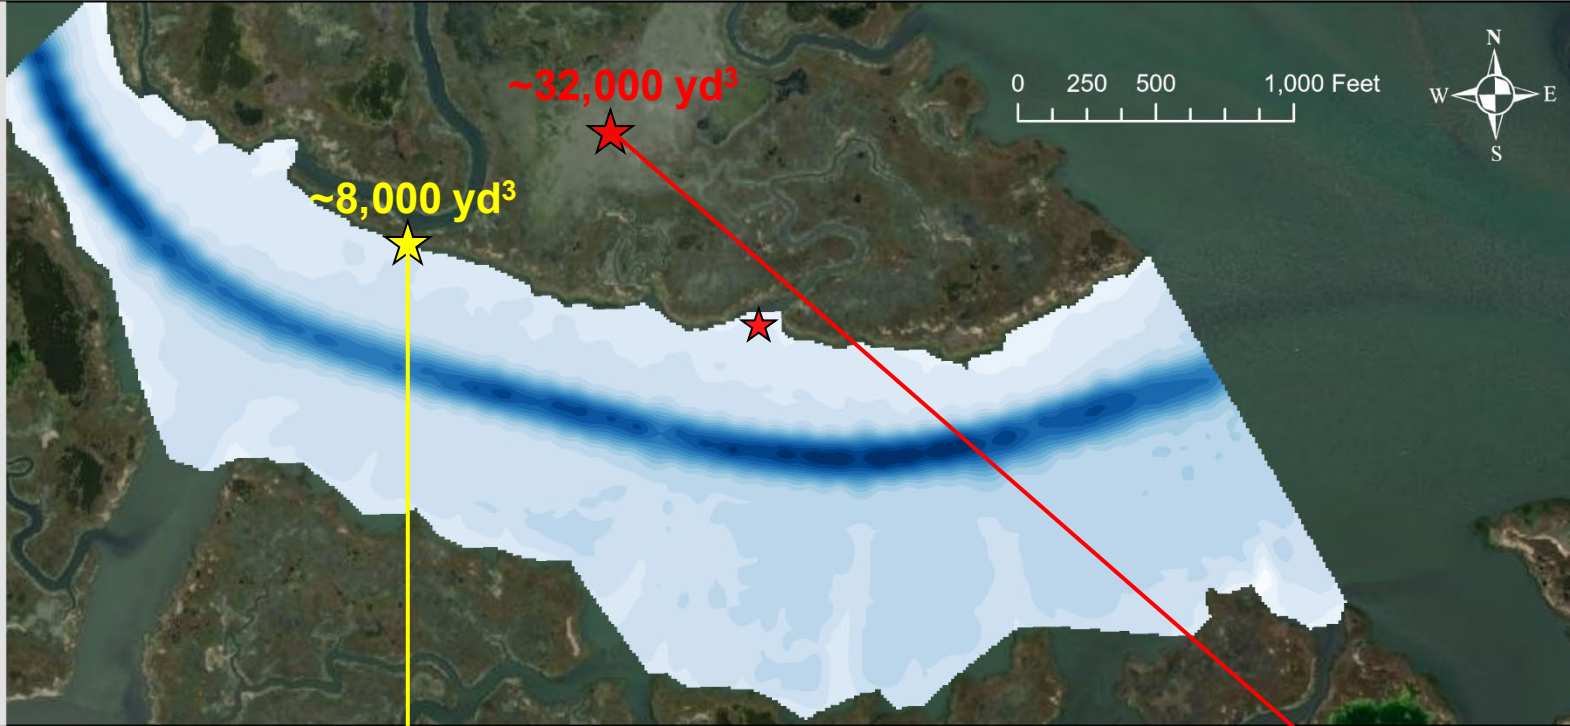
Placement in September 2020

~40,000 yd³ of fine
sand and mud

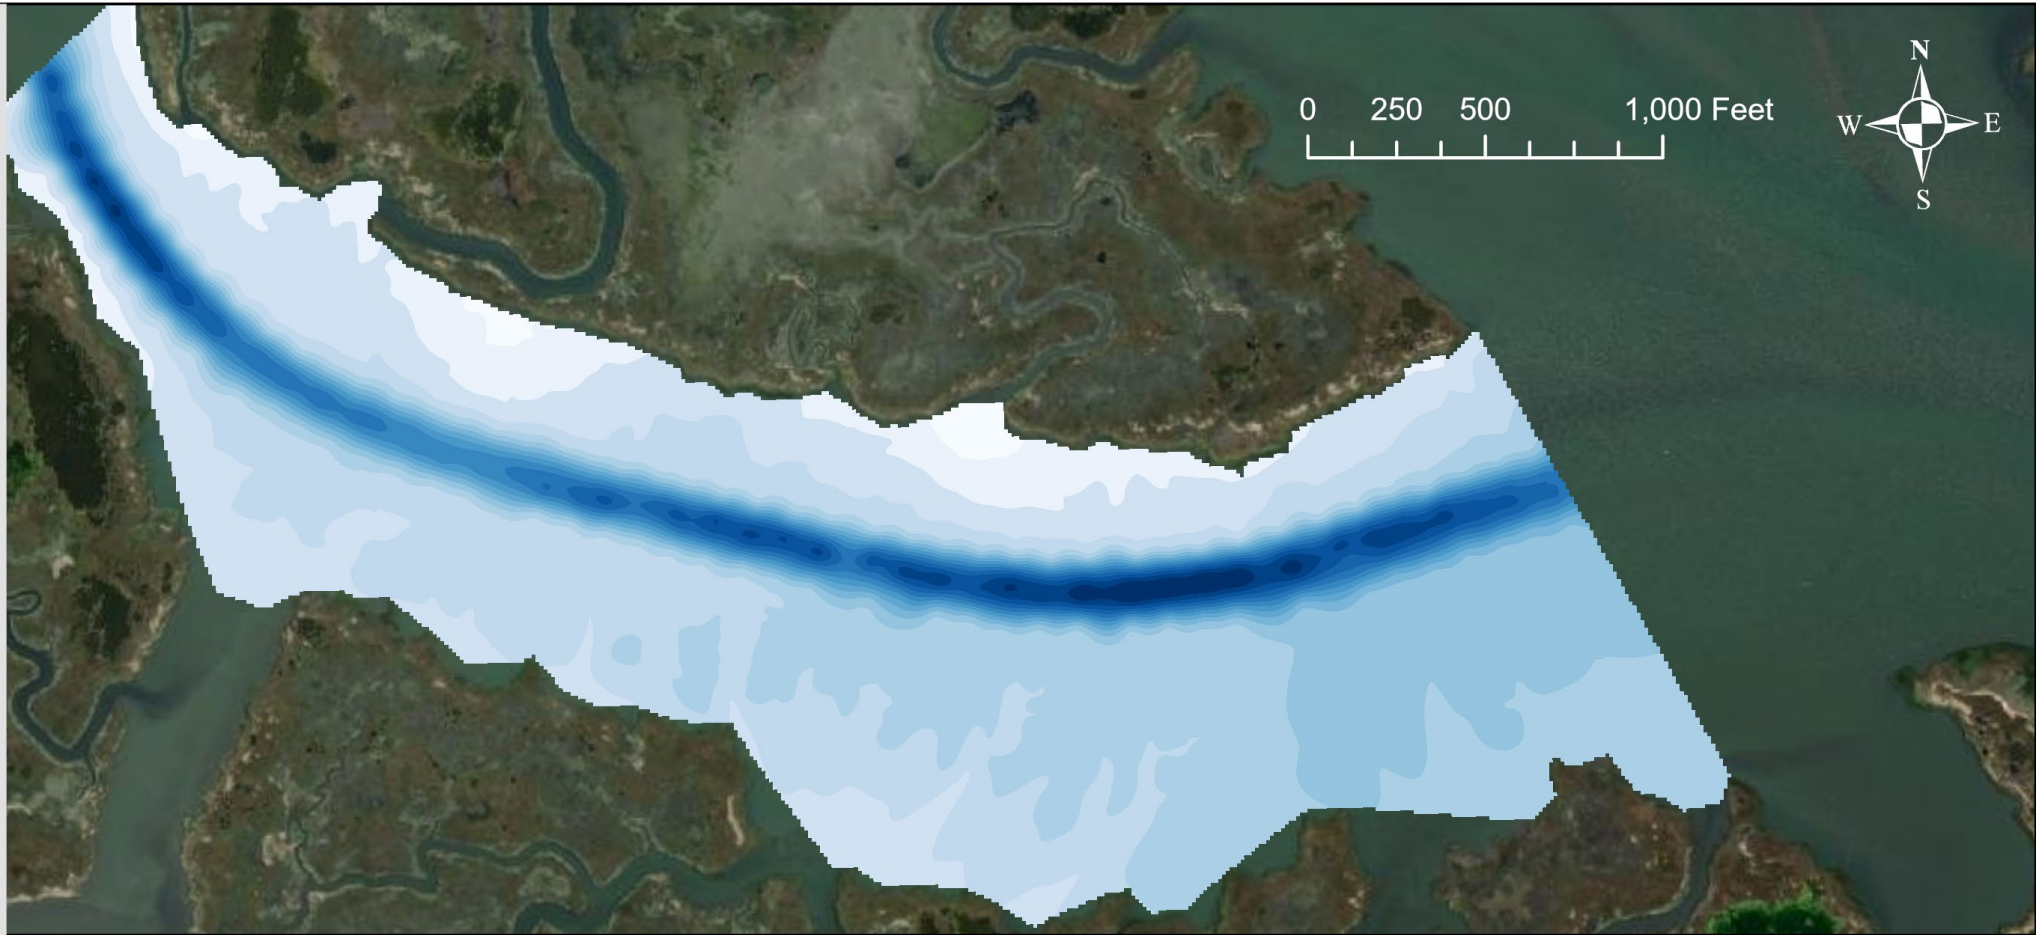
Bathymetry Southern Gull Island March 2021

Approximately 6 Months After Placement

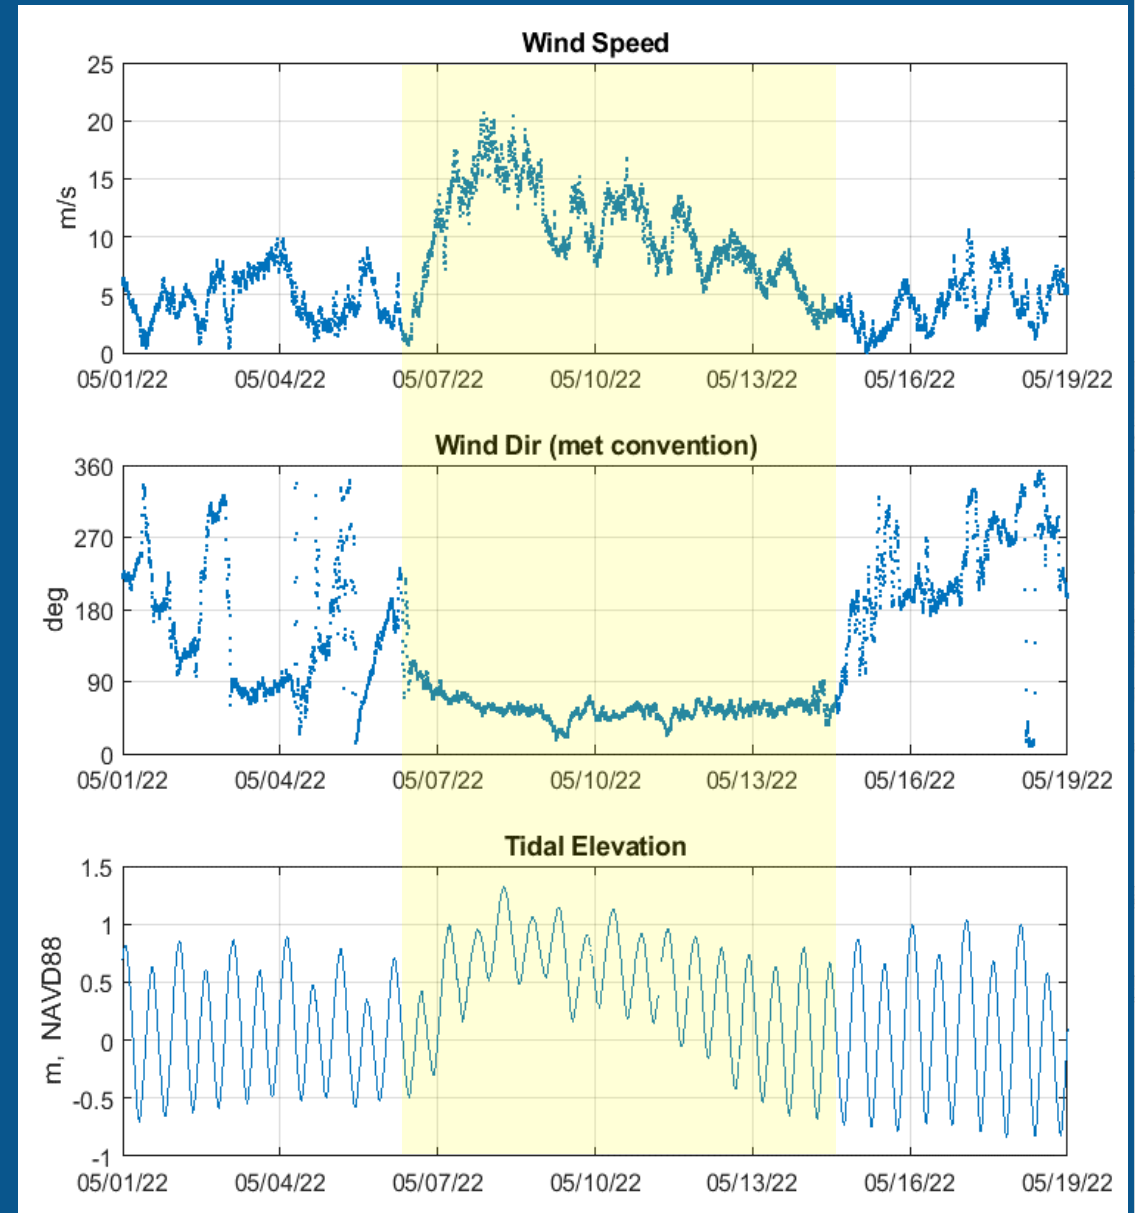
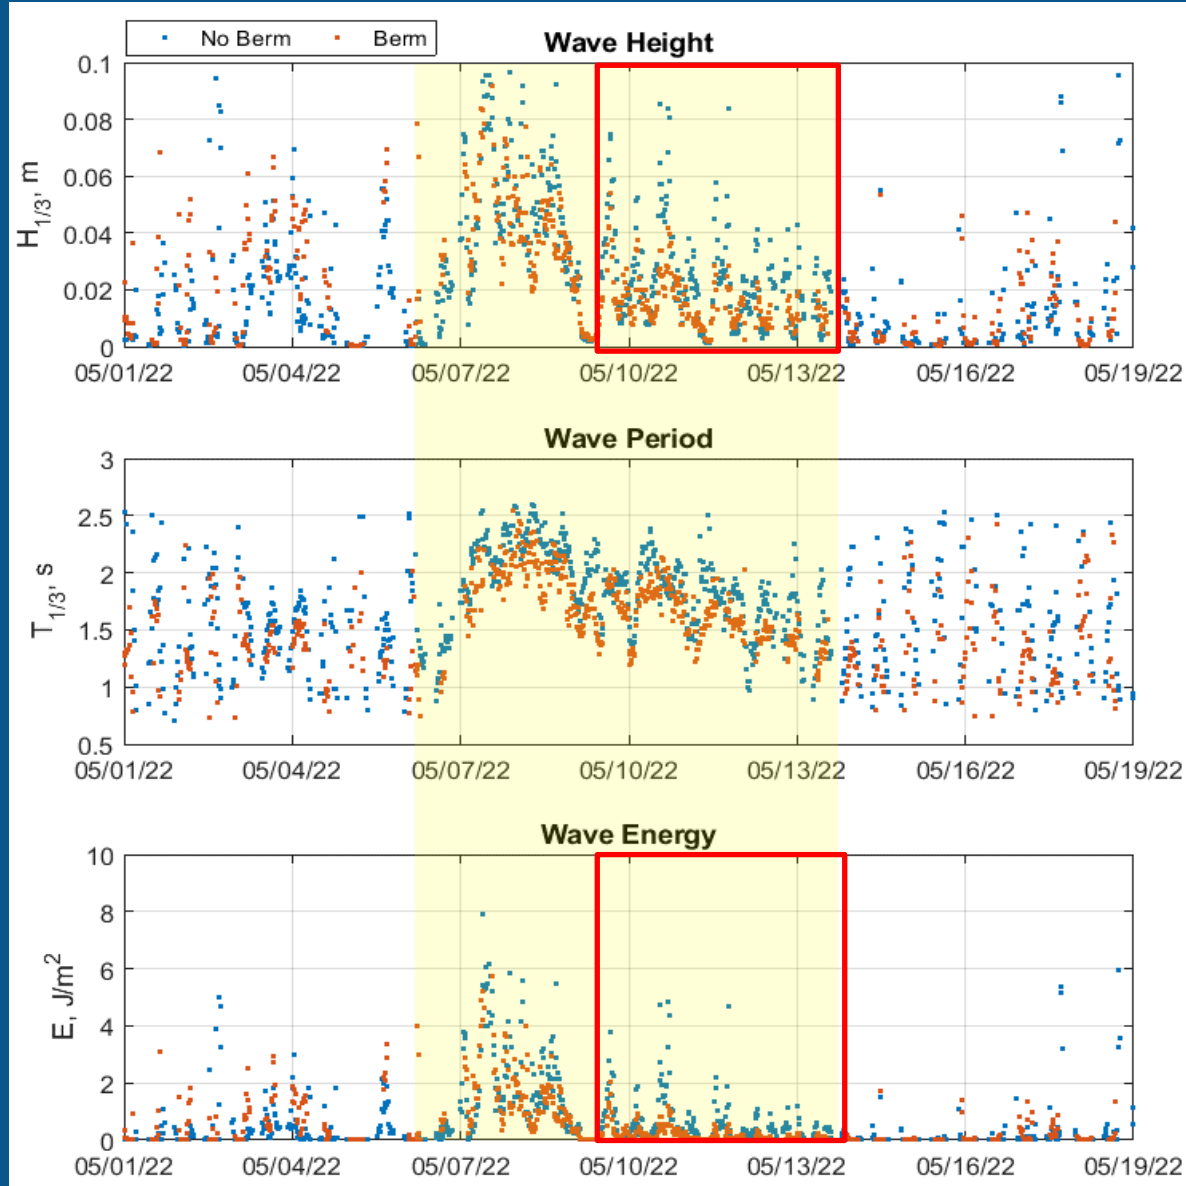
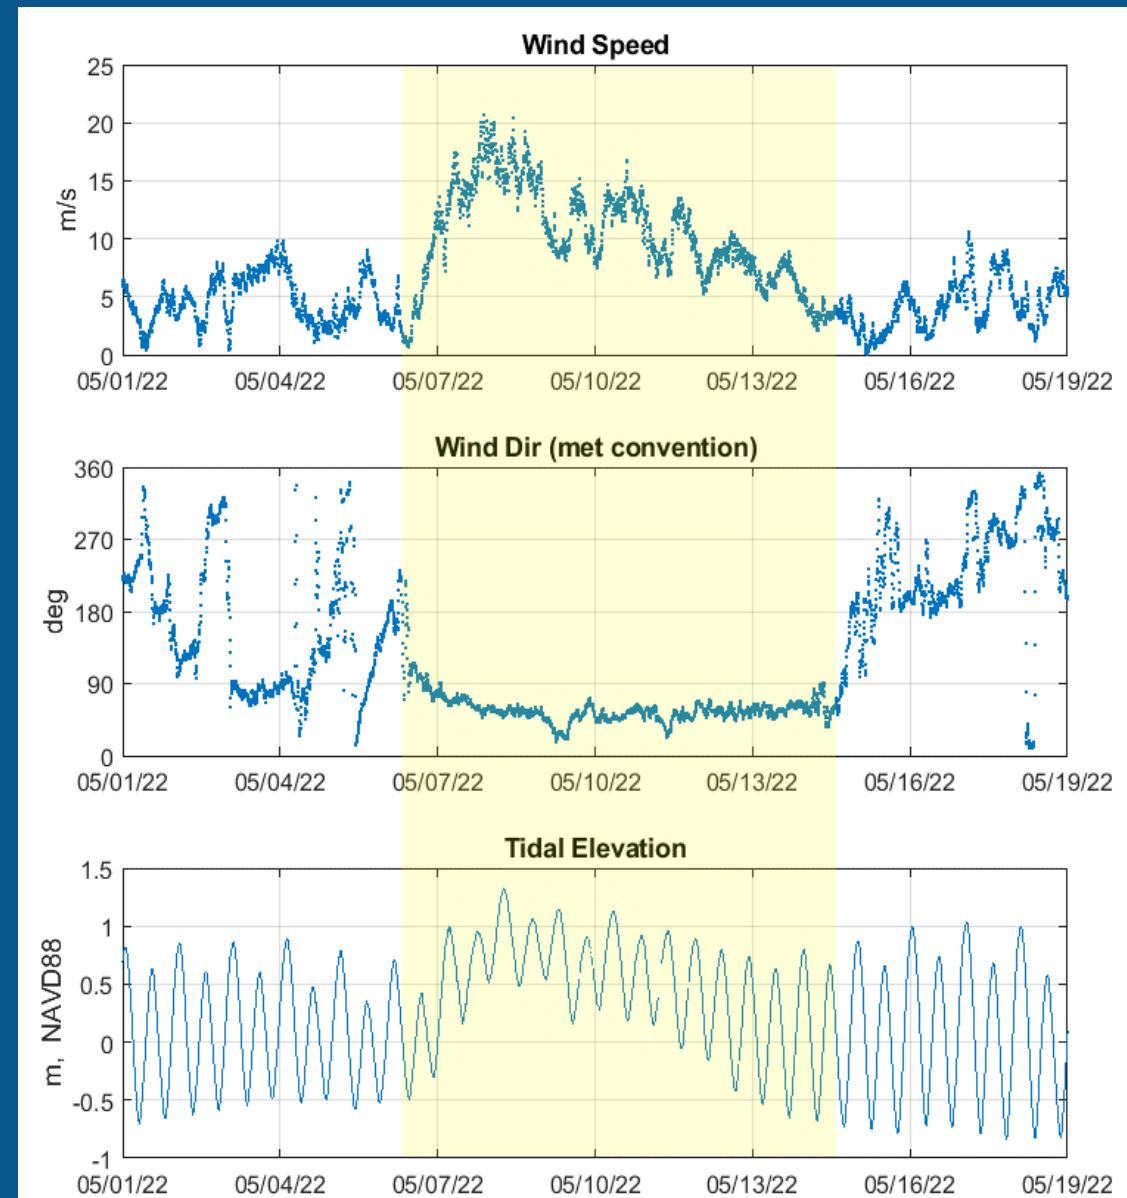
Berm Impacts on Wave Energy

Preliminary analysis of May 2022 Event:

- Sustained, Strong Winds from the NE pushing water up onto marsh.
- Marsh inundated for days.

Preliminary analysis suggests berms slightly reduce wave height and energy at marsh edge, particularly during tail end of event.

- Dredge material placement of muddy sediment at Gull Island successfully created two depositional features along the marsh edge.
- Placed material showed evidence of cohesion and stability 16 months after placement without any containment/confinement.
- Reduction in feature volume due to a combination of erosion, consolidation, and compaction.
- Initial analysis indicates that the berm features can reduce wave energy at the marsh edge.
